# Manhole Inspection Summary

Manhole # S39U1\_010MH

Insp Date: **2/19/08 9:42 AM**

**Location** Address: **204 Maude Ave** Cross Street: **Chesapeake Ave.**

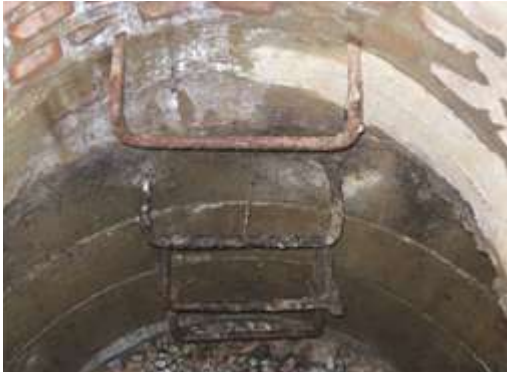
Steps

**Steps** Count: **4** Missing: **0** ☒ **Corroded**

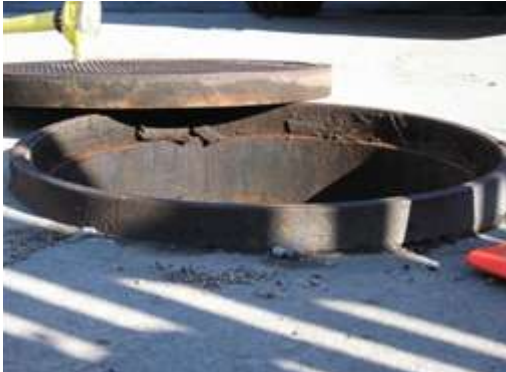
Defect 1

Above grade

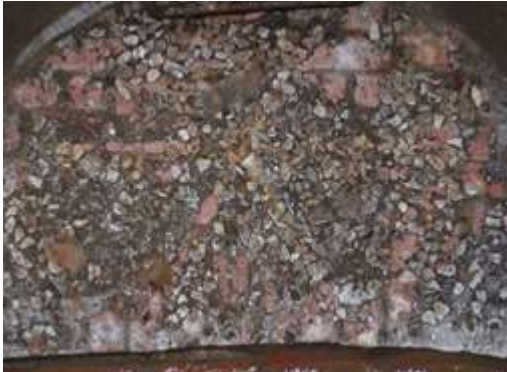
Defect 2

Bench

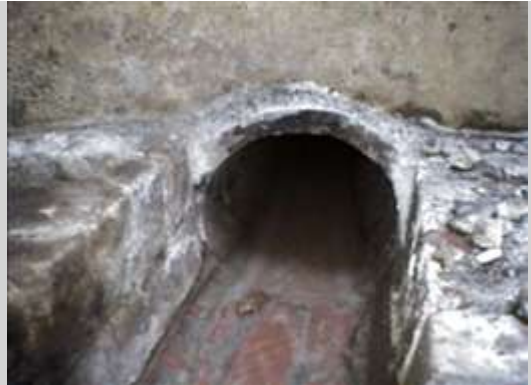
12 O'Clock Outflow

8 in. Circular Gravity Sewer  
Pipe Out @ 12 O'Clock

Pipe Height: **10.8** (in.) Rod and Bar (Angled)  
Pipe Material: **Clay** ☐ Pipe Lined  
Invert Depth: **7.48** (ft.) Flow Characteristics: **Fast**  
Deposits: ☒ None ☐ Mud ☐ Sludge ☐ Debris ☐ Grease  
Silt Depth: (in.) Deposits Extent:  
Infiltration: **None** Pipe Seal Cond: **Sound**

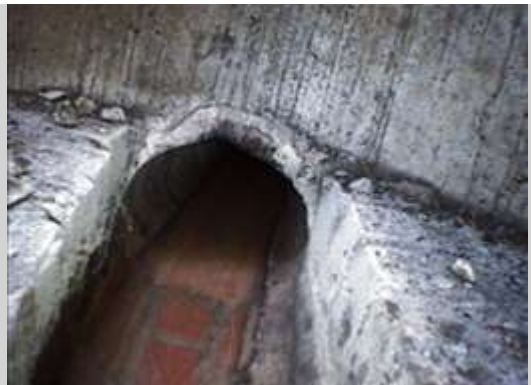
6 O'Clock Inflow

8 in. Circular Gravity Sewer  
Pipe In @ 6 O'Clock

Pipe Height: **9.6** (in.) Rod and Bar (Angled)  
Pipe Material: **Clay** ☐ Pipe Lined  
Invert Depth: **7.28** (ft.) Flow Characteristics: **Fast**  
Deposits: ☒ None ☐ Mud ☐ Sludge ☐ Debris ☐ Grease  
Silt Depth: (in.) Deposits Extent:  
Infiltration: **None** Pipe Seal Cond: **Sound**
